# Manhole Inspection Summary

Manhole # S33II1008MH

**Location** Address: **4006 ST PAUL ST**

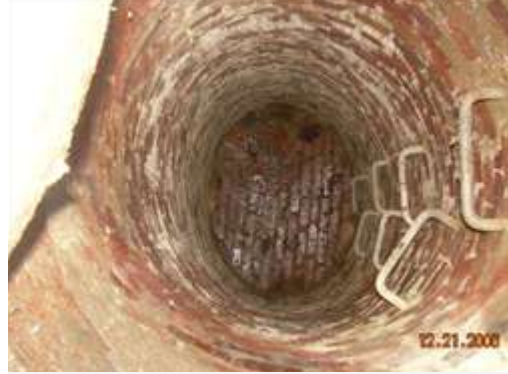
Top View

Infiltration: ☐ None ☐ Joint ☐ Cracks ☐ Mortar ☐ Roots ☒ **Wall**

**Channel** Material: **Brick** ☐ Parged ☒ **Debris** (not Condition related)

Barrel infiltration. Channel debris.

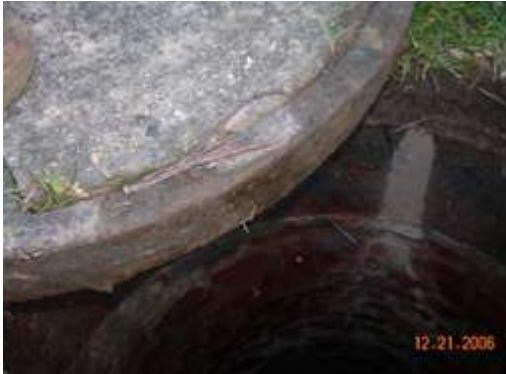
Defect

**Frame** Offset: **0** (in.) Condition: ☐ Sound ☐ Cracked ☒ **Leaks**

Infiltration: ☐ None ☒ **Joint** ☐ Cracks ☐ Mortar ☐ Roots ☒ **Wall**

Frame leaks. Adjustment infiltration.

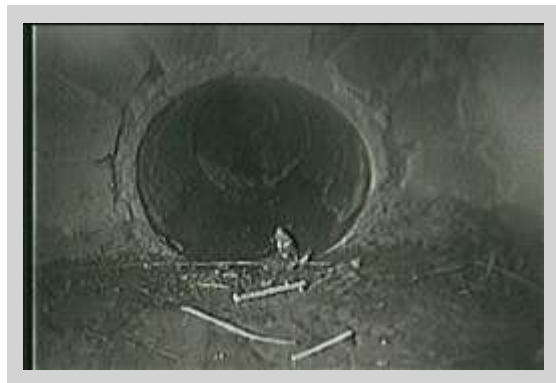
8 in. Circular Gravity Sewer

Pipe Out @ 12 O'Clock

Deposits: ☐ None ☒ **Mud** ☐ Sludge ☐ Debris ☐ Grease

Infiltration: **Evidence**

Pipe Seal Cond: **Cracked**
